# Strataflex Case study

## Albany Lakes Art Bridge

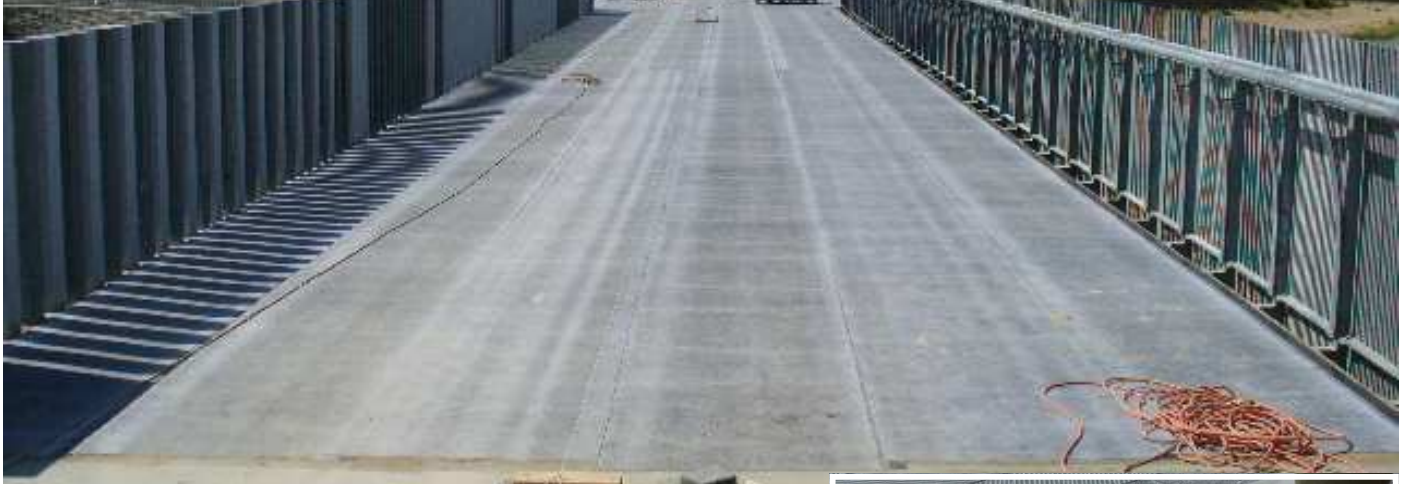
In 2008, 300 m2 of Stratflex was used to ensure a fracture free installation of the Albany Lakes Arts Bridge. Since then , no cracks have appeared in the stone or grout joints.

Albany Arts Bridge presented several technical issues. The bridge movement, coupled with the natural stone tiling meant that there needed to be a flexible solution to avoid cracking of the stone and grout. **Protective Surfaces** provided a comprehensive solution.

**Strataflex** anti-fracture was applied directly to the bridge to ensure that a lateral movement of up to 10mm was allowable.

**Technorap 2** from **Technokolla** was then used to adhere the large format limestone to the **Strataflex**. This high spec C2 / S1 adhesive exhibits high flexibility and its fast set nature allowed for a timely grout application.

Efflorescence was effectively eliminated due to the isolation of the substrate by the **Strataflex** and the minimal salt content in the adhesive.

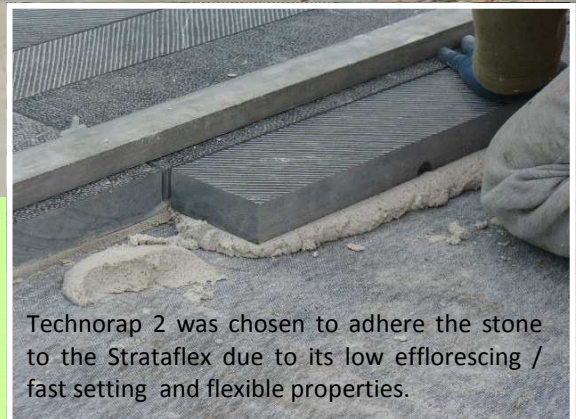
Technorap 2 was chosen to adhere the stone to the Strataflex due to its low efflorescing / fast setting and flexible properties.
